RE: *Initial Site Investigation Report,
Wheeler Sports, Lyndonville, VT 98-2509*

INITIAL SITE INVESTIGATION REPORT

WHEELER SPORTS
724 Broad Street
Lyndonville, Vermont

9 March 1999

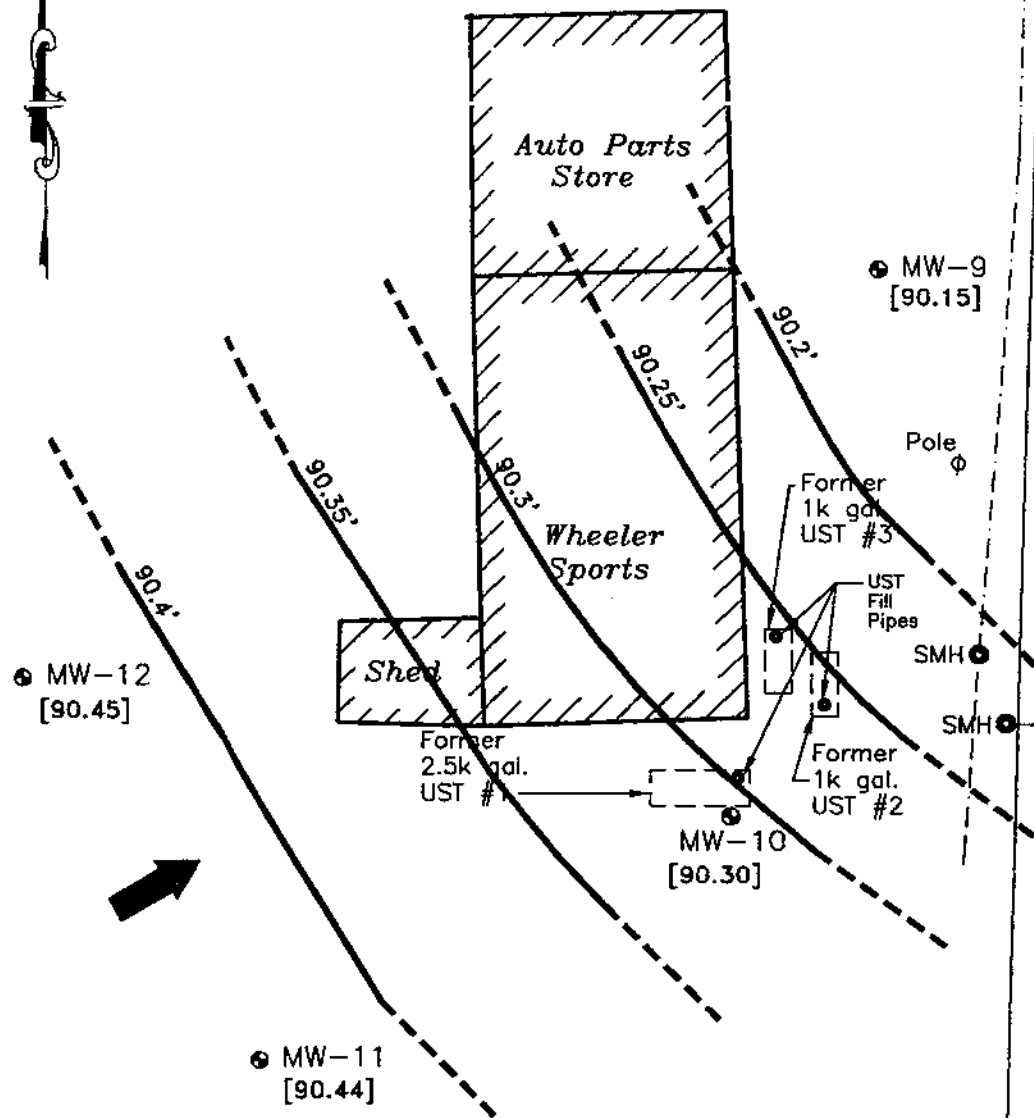
MW-9 was installed 8 June 1998 as part of an on-going investigation of petroleum contamination at the Ville Garage site. This well was used to supplement water-table elevation information.
